DEPARTMENT OF NATURAL RESOURCES
DIVISION OF OIL, GAS AND MINING

RE: Site Inspection, James Warr, Yankee Mine, S/049/022, Utah County, Utah

Purpose of Inspection: To examine the site in response to a request for file closure.

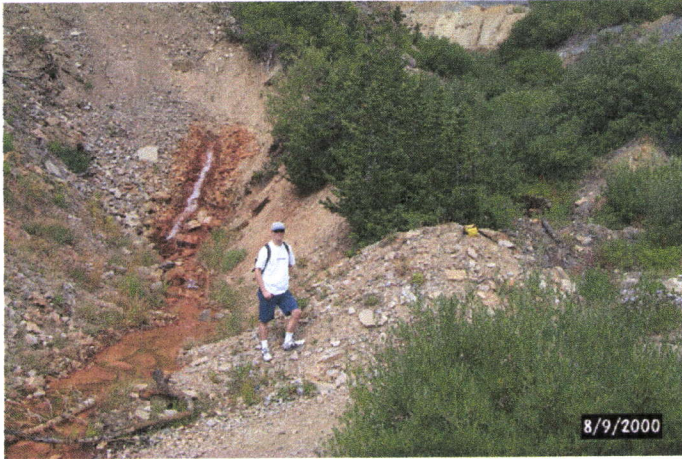
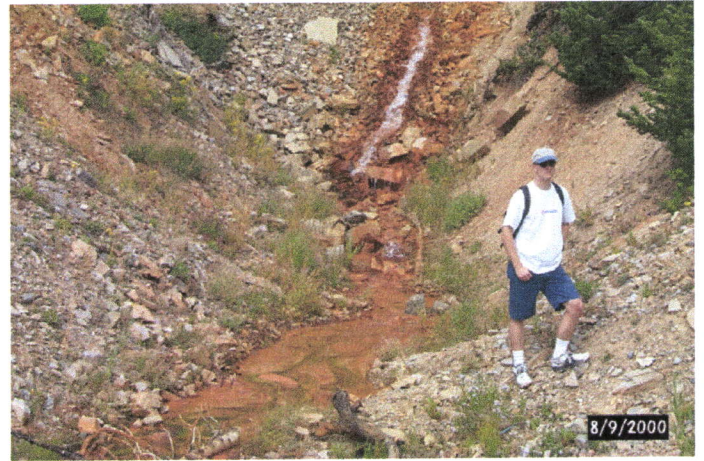
The inspection began at the lower end of the project area where the two adits are shown at the Yankee mine. The adit to the left (south) of the drainage had caved and water was discharging from the rubble. The water left a reddish stain where it came in contact with the rock or soil. Algae was growing in the water as it flowed across the top of the waste dump and down the dump face where it joined with the flow from the drainage channel. A GPS unit was used to record a location point on a small pile between the caved adit and the main stream channel. Photographs were taken from several vantage points looking towards the main drainage channel with the yellow GPS bag visible at the location point. The second adit shown on the map at this location was not distinctly visible. Water from the main drainage channel was flowing through a culvert under the access road. It was difficult to determine how much disturbance had occurred in this area from this mine notice.

↓ WATER FROM CAVED YAUKEE MINE PORTAL

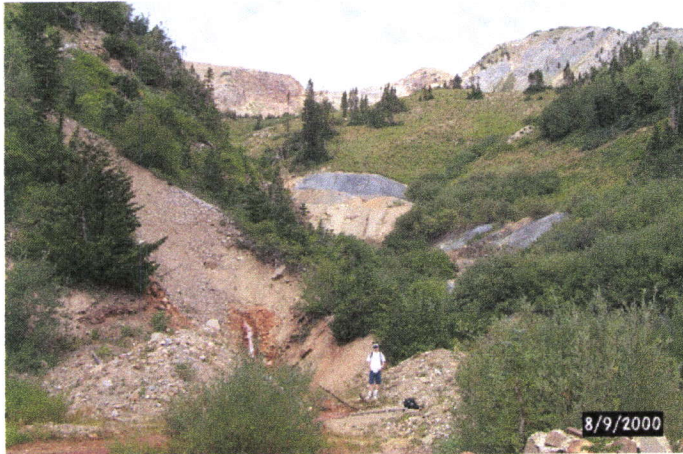
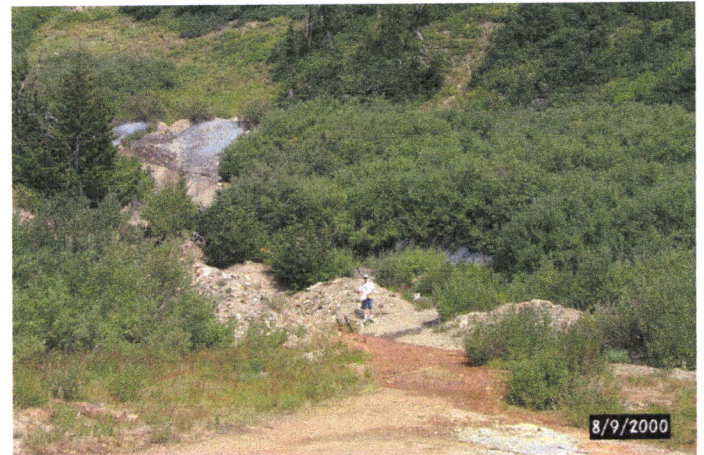
We walked up the road along the drainage towards the Belorophan Mine examining the disturbances along the way. A short road spur led off the main road to the next pad (moving up the drainage). The next pad area may have included another caved adit, although it was difficult to be certain. Given the extent of the existing mine dump it was difficult to determine how much disturbance had been created here from this notice. There were signs of recent digging in the upper surface of the dump here, probably from rock hounding activities. Small pyrite crystals were common occurrences on the dump

materials. Photographs were taken of this pad area to document the current status. A large boulder stands out as a noticeable feature at this pad.

NEXT PAD IN DRAINAGE ABOVE
YAUKEE PORTALS

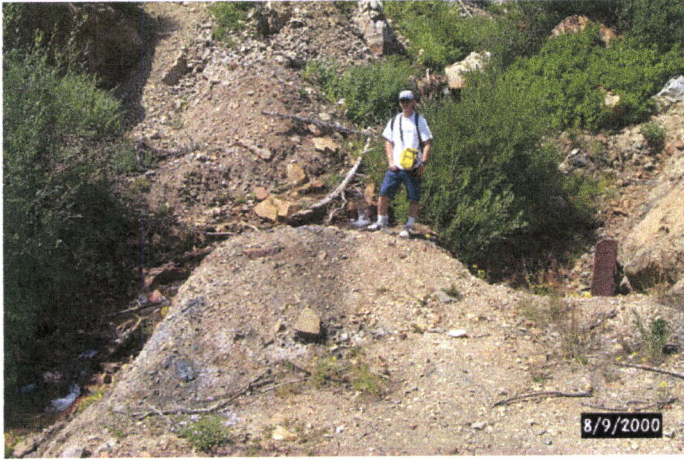
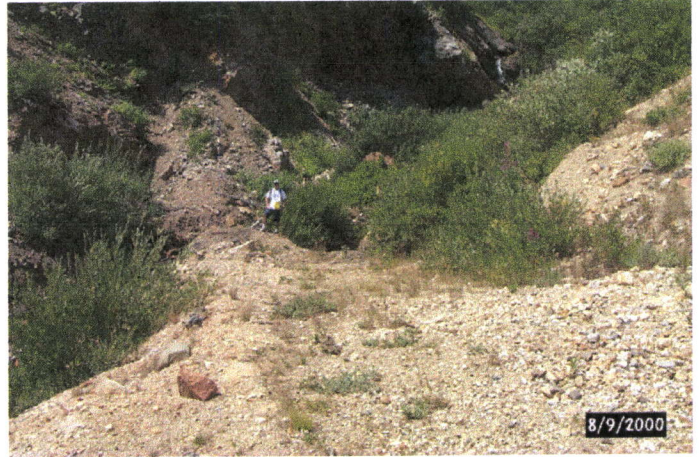
Further up the road was another short spur road leading off the main road to another pad area. Significant features at this pad included a standing metal plate near the talus slope. There may have been another adit here which had caved. It was difficult to determine how much disturbance had occurred at this area under this mine notice. There were signs of rock hounding activities at this area as well.

↓ SECOND PAD UP FROM YAUKEE PORTALS

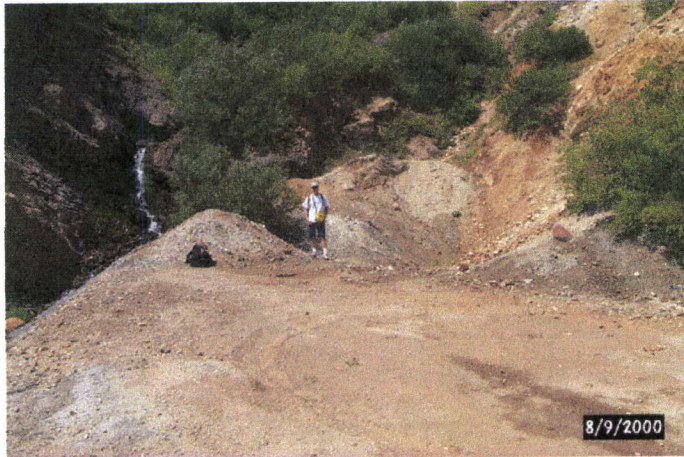
We continued up the gulch road up to where the upper road crosses the stream. A photo was taken looking down the drainage from this upper road. The gray and red mine dumps, and pads in the drainage are visible in this photo. The main access road and turnoff to the mine site are also visible in the background. We continued on the upper road which led past an open mine adit with narrow gauge rail coming out. The upper road ends at a cabin with signs indicating it is on private property.

TURNOFF TO
YAUKEE MINE

MAIN ACCESS ROAD

LOOKING DOWN THE DRAINAGE FROM THE
UPPER ROAD
